New York State Department of Transportation

Yellow Flag NB22CTW011

BIN: 1065318

Feature Carried: 278I278IX2M23027

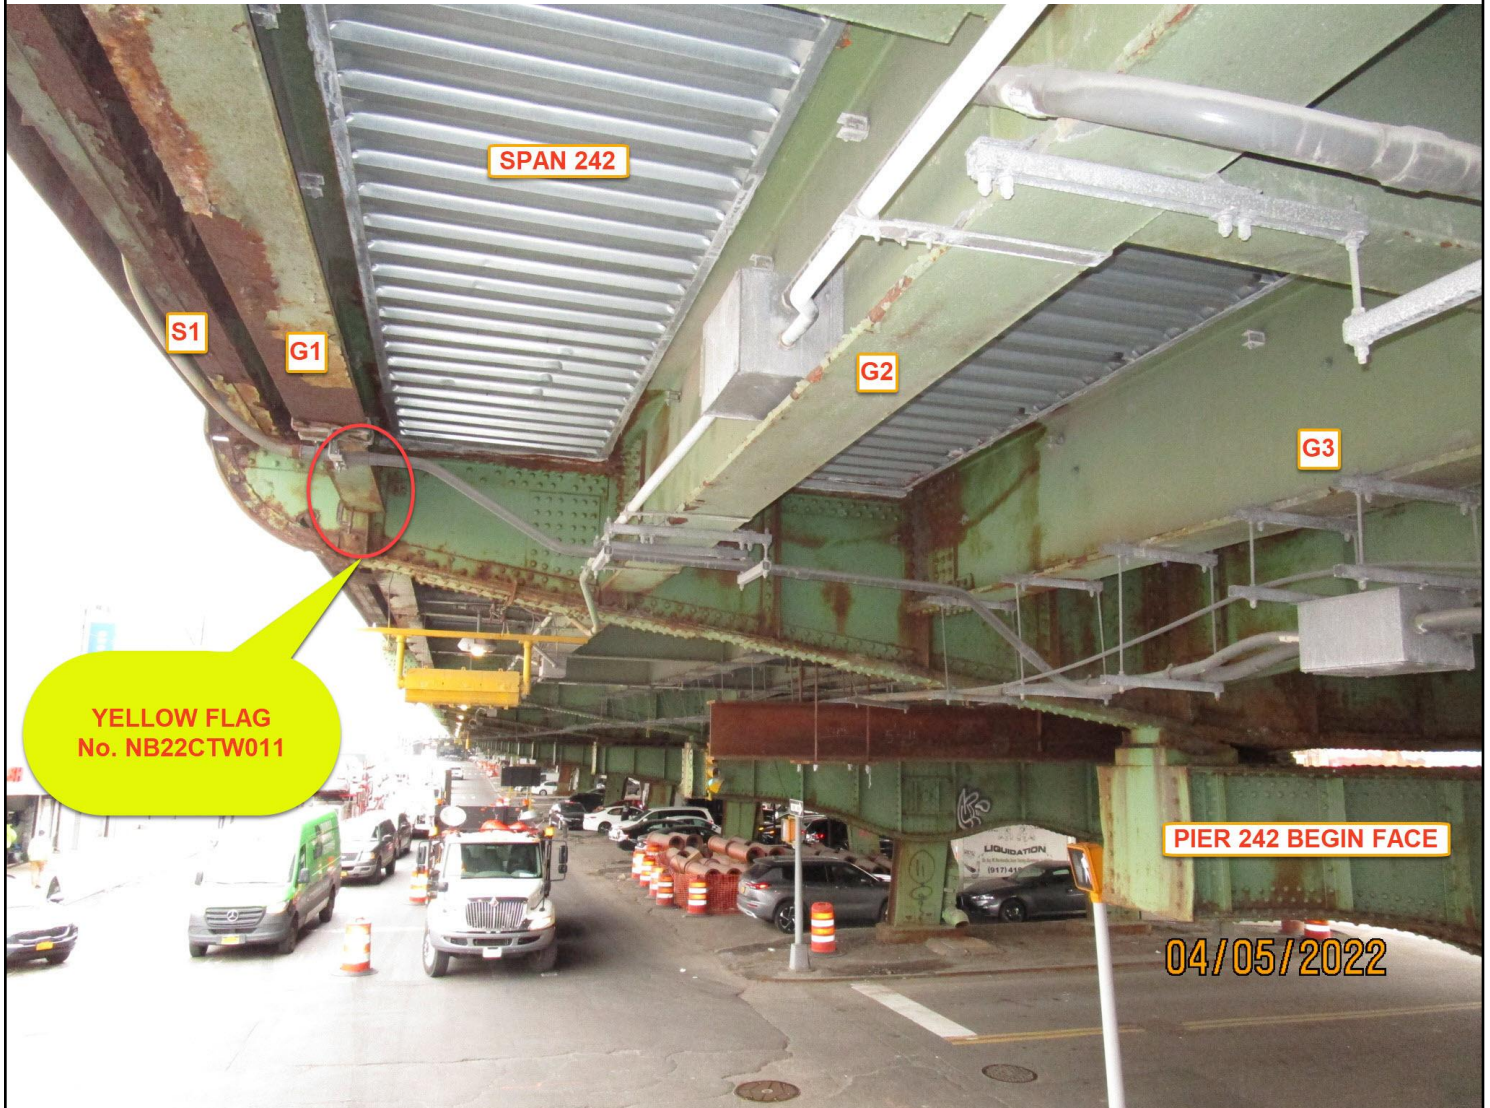
Photo Number: 1

Location: Span 242, Girder G1 at Pier 242 (Photo 1).

Attachment Description: Span 242 Girder G1 at Pier 241 - General View of flagged location. Looking End Right.

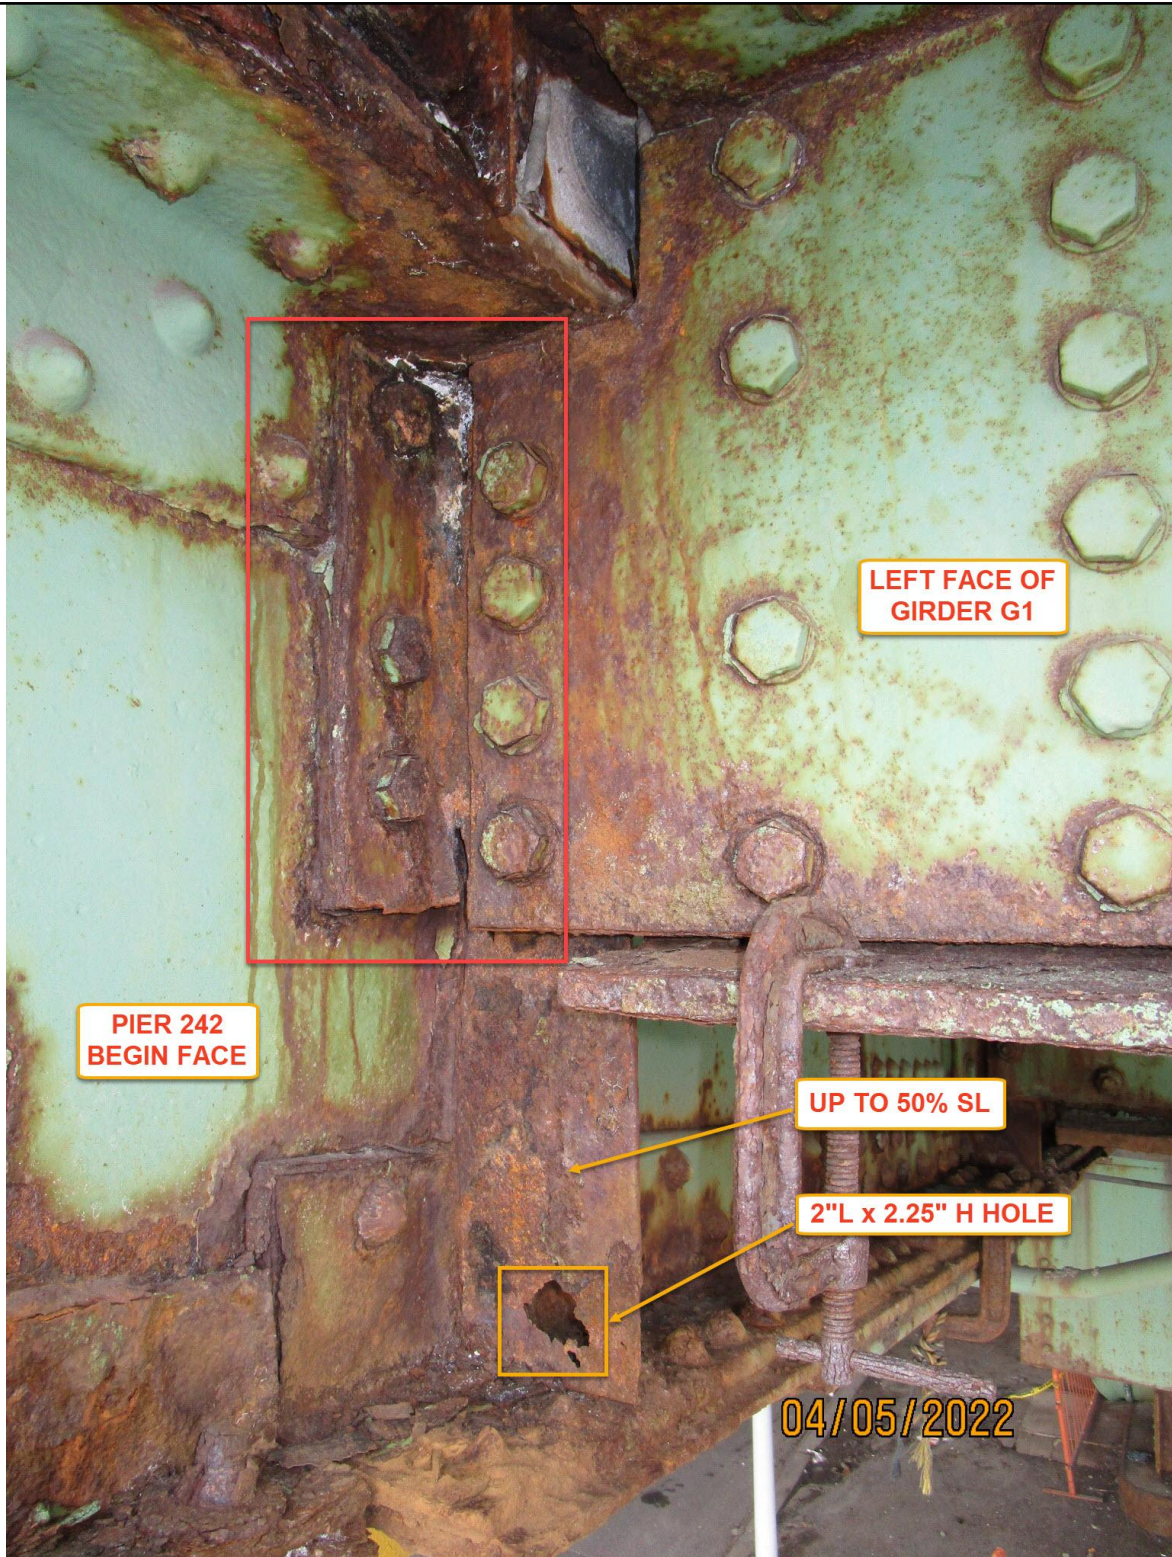
Photo Number: 2

Description: The right connection angle at Girder G1 connection to the pier cap at Pier 242 exhibits a 2-1/8"H x 1/2"W (previously 2"H x 1/2") vertical corrosion crack at the lower fillet section and 2-3/4"H x 1"W (previously 2-1/2"H x 1"W) corrosion crack at the upper fillet section (Photos 2 and 3). The remaining 8.5 inches of the connection angle height exhibits up to 50% section loss.

The left connection angle exhibits a corrosion hole below the Girder web measuring 2"H x 1/2"W (previously 1-1/2"H x 1/2"W); a hole at the top portion measuring 1"H x 4" W (previously measuring 1" diameter), and a 2-1/4"H x 2"L hole (previously 2"H x 2"L) at the base (Photos 2 and 4). The remaining area of the left connection angle exhibits up to 30% section loss for 5"H at the top and up to 50% section loss at the lower section.

Attachment Description: Span 242 Girder G1 at Pier 242 - Left Face. General View of Girder G1 end. Corrosion cracks and heavy section loss of the left connection angle. Looking Right.

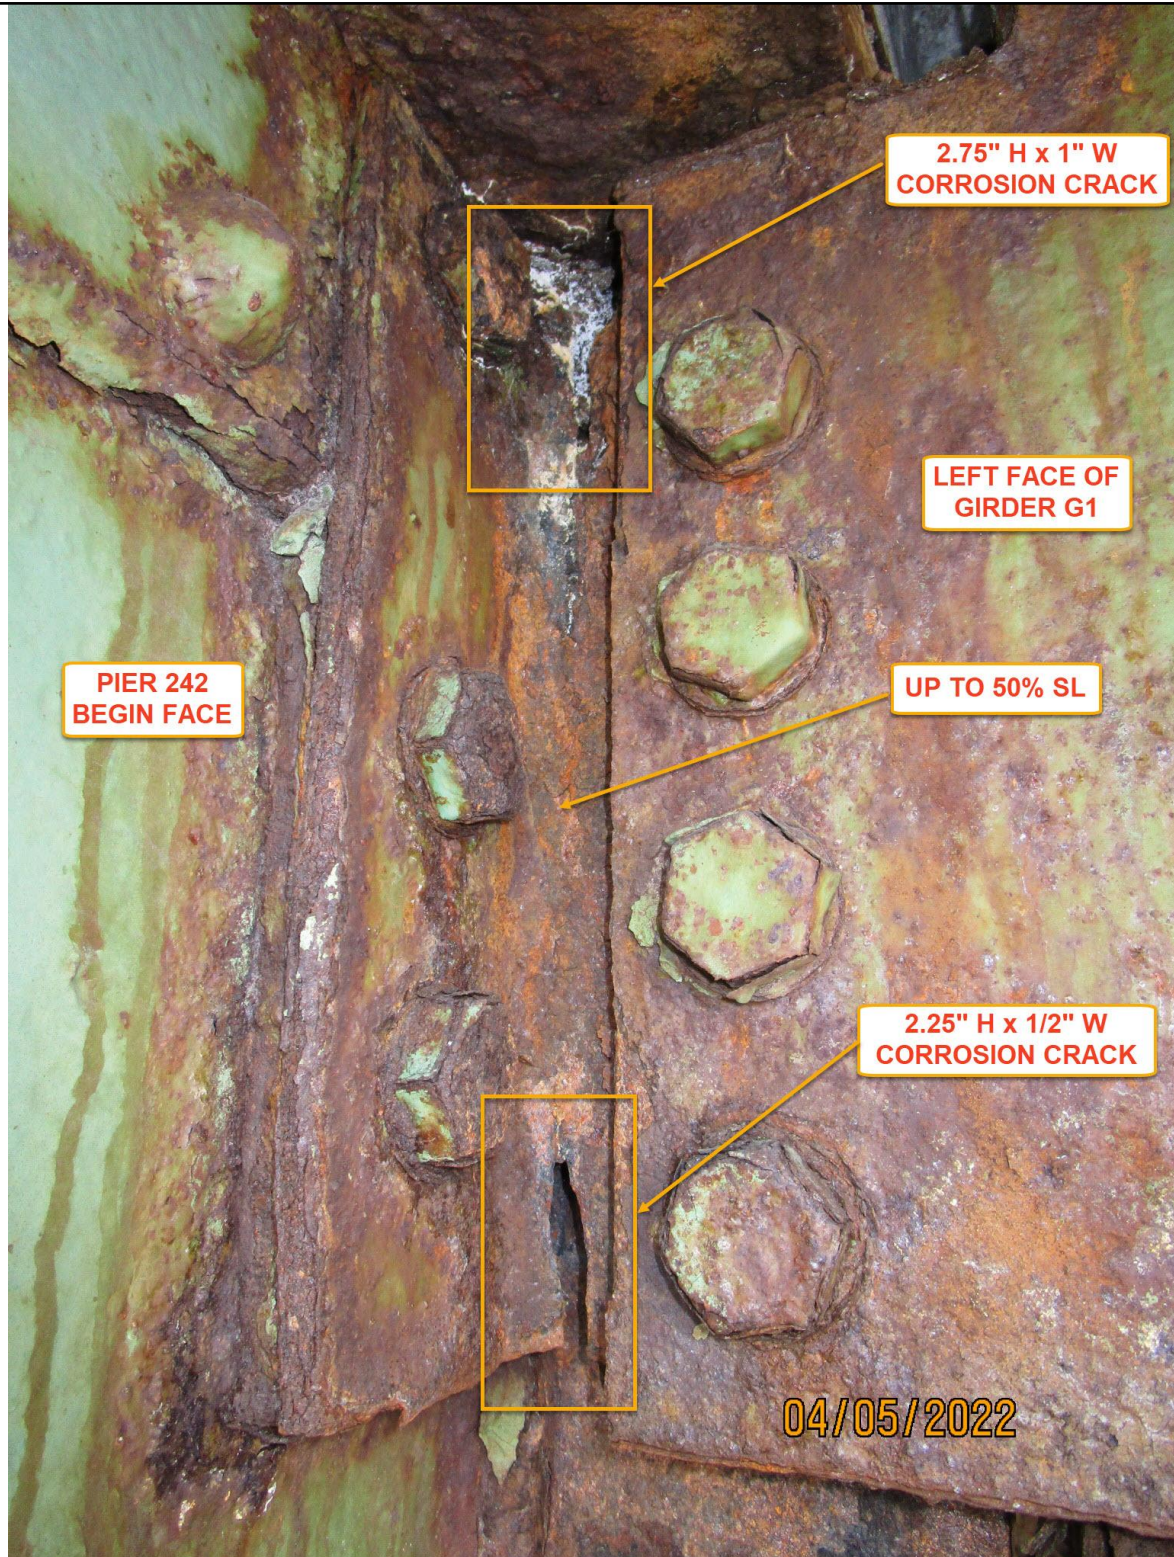
Photo Number: 3

Attachment Description: Span 242 Girder G1 at Pier 242 - Left Face. Close-up view of flagged location. Corrosion cracks and heavy section of the left connection angle. Looking Right.

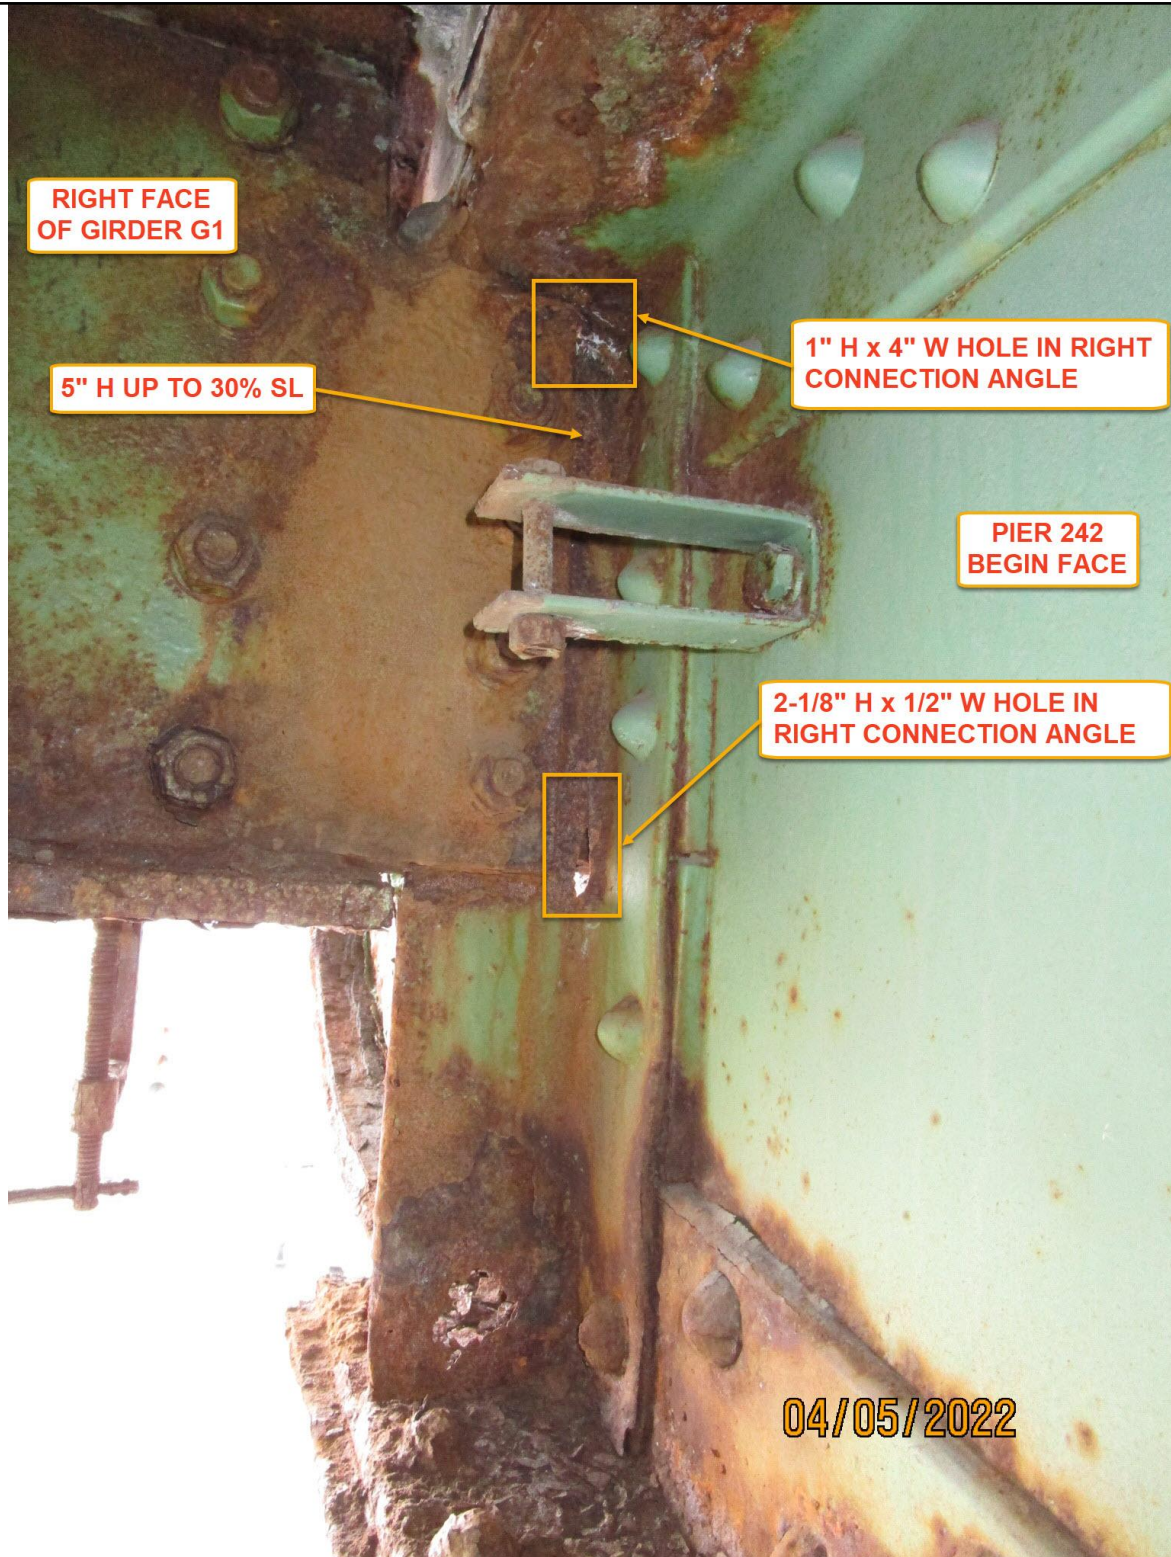
Photo Number: 4

Attachment Description: Span 242 Girder G1 at Pier 242 - Right face. Corrosion hole and section loss. Looking Left.

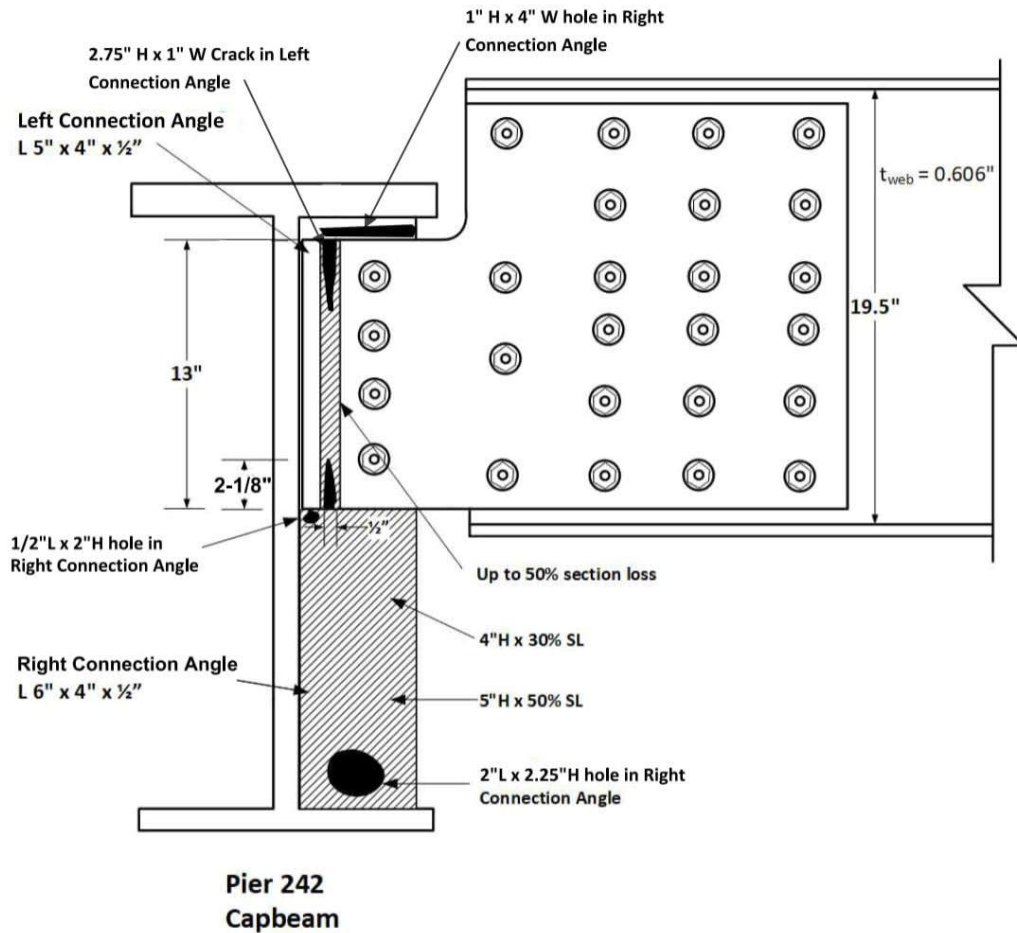
Photo Number: 5

Span 242, Girder G1 at Pier 242 (Looking right)

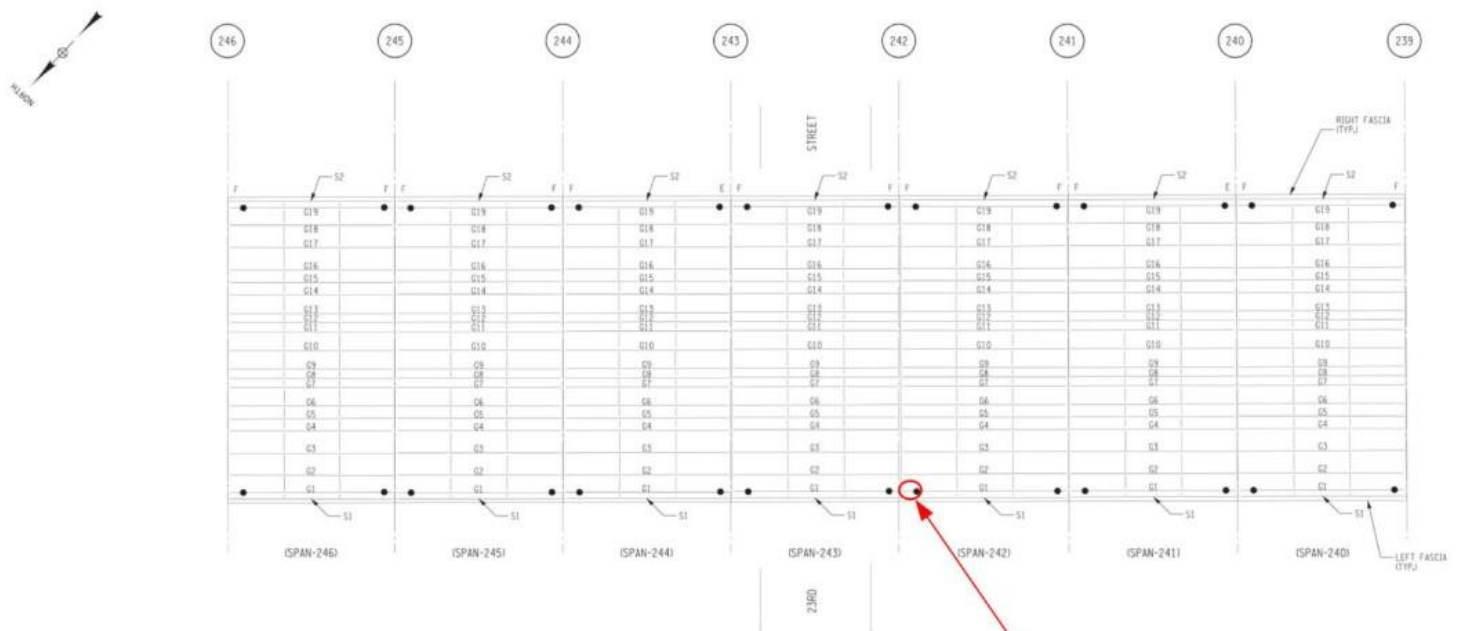
Photo Number: 6

Location of
Yellow Flag
